Manhole Inspection Summary

Manhole # S51O__042MH

Insp Date: **4/23/08 1:47 PM**

Location Address: **2701 boston street**

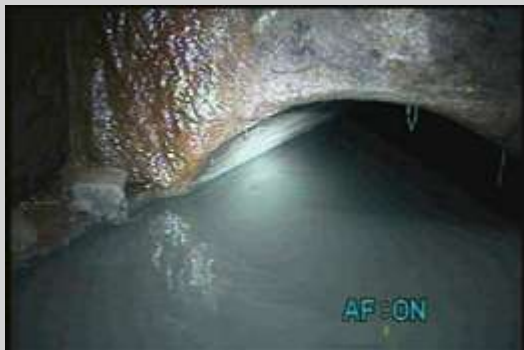
12 O'Clock Outflow

36 in. Circular Gravity Sewer
Pipe Out @ 12 O'Clock

Pipe Material: **Concrete** ☐ Pipe Lined

Invert Depth: **21.10** (ft.) Flow Characteristics: **Fast**

Infiltration: **None** Pipe Seal Cond: **Unknown**

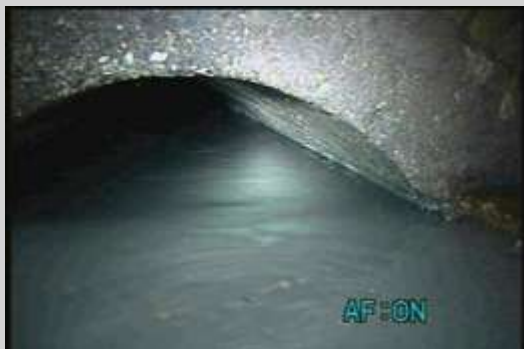
6 O'Clock Inflow

36 in. Circular Gravity Sewer
Pipe In @ 6 O'Clock

Pipe Material: **Concrete** ☐ Pipe Lined

Infiltration: **None** Pipe Seal Cond: **Unknown**
